SUBJECT: Joint Committee on Aircraft Aging/Joint Group on Pollution Prevention
(JCAA/JGPP) Lead-free Solder Study (JN06-017 thru JN06-019)

Project: Joint Committee on Aircraft Aging/Joint Group on Pollution Prevention (JCAA/JGPP) Lead-free Solder Study

Date Completed: October 23, 2006

Job Numbers: JN06-0017, JN06-018, JN06-019

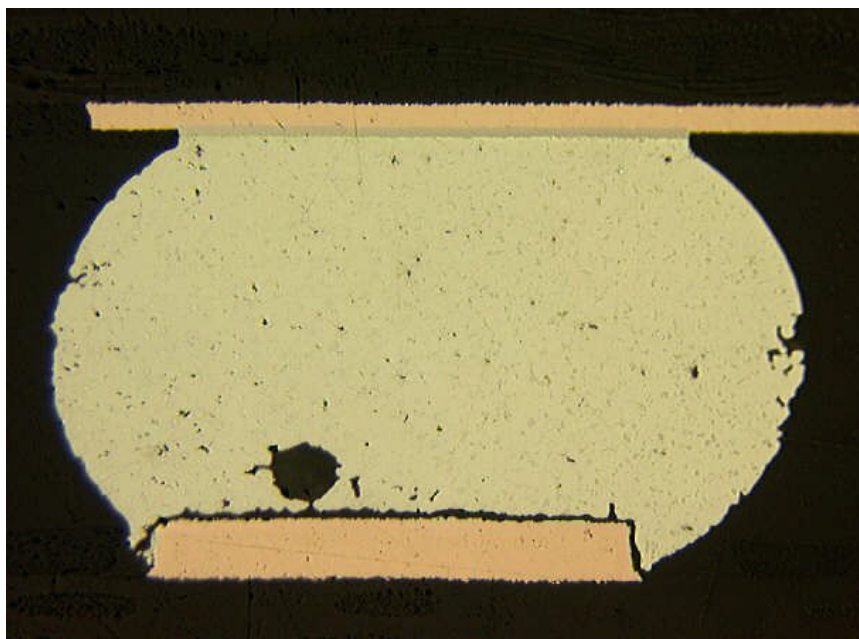
Figure 8. Ball to pad interface fracture in component BGA U2 from Thermal Board 158.

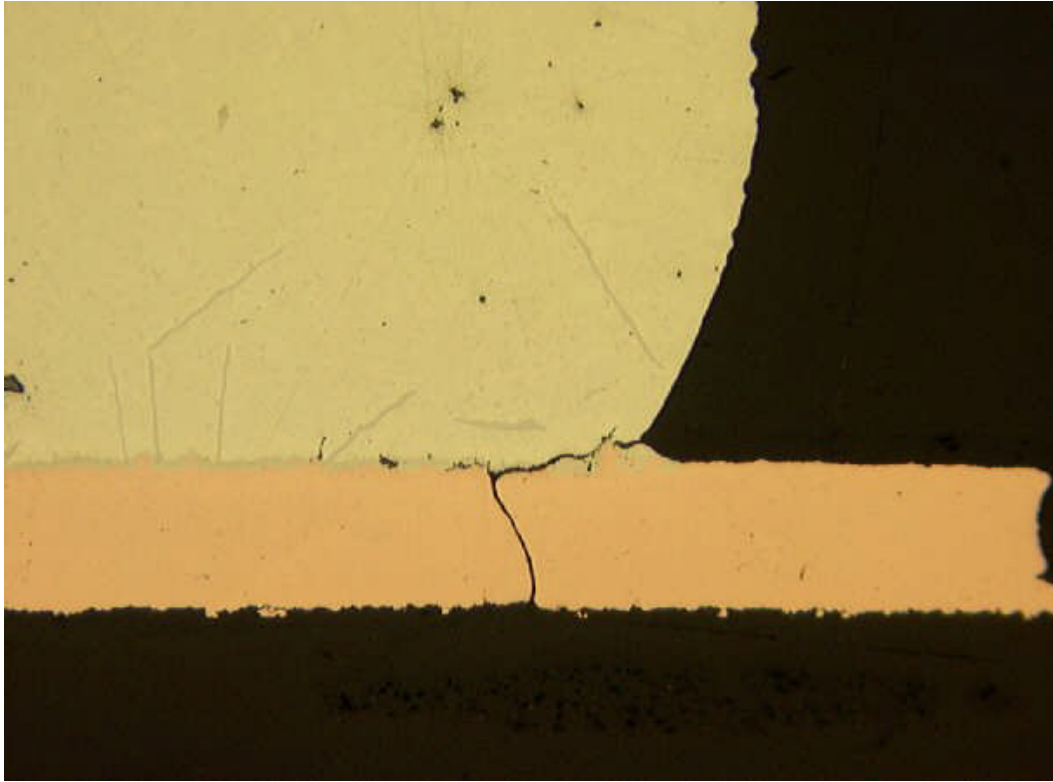
Figure 9. Copper trace fracture in component BGA U43 from Mechanical Shock Board 98.

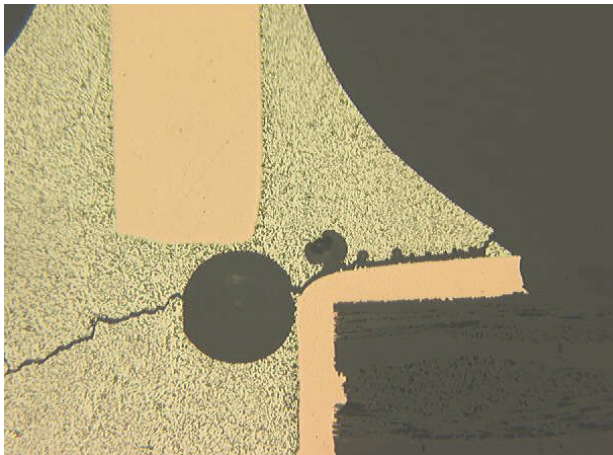
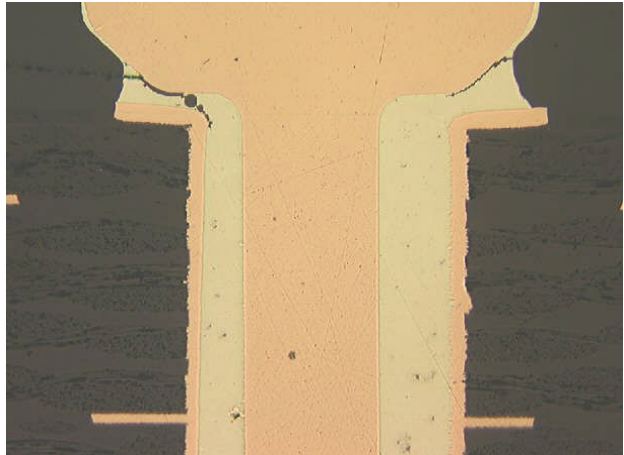
Figure 10. Lead to solder fracture in component PDIP U30 from Mechanical Shock Boards 28 and 136, respectively.

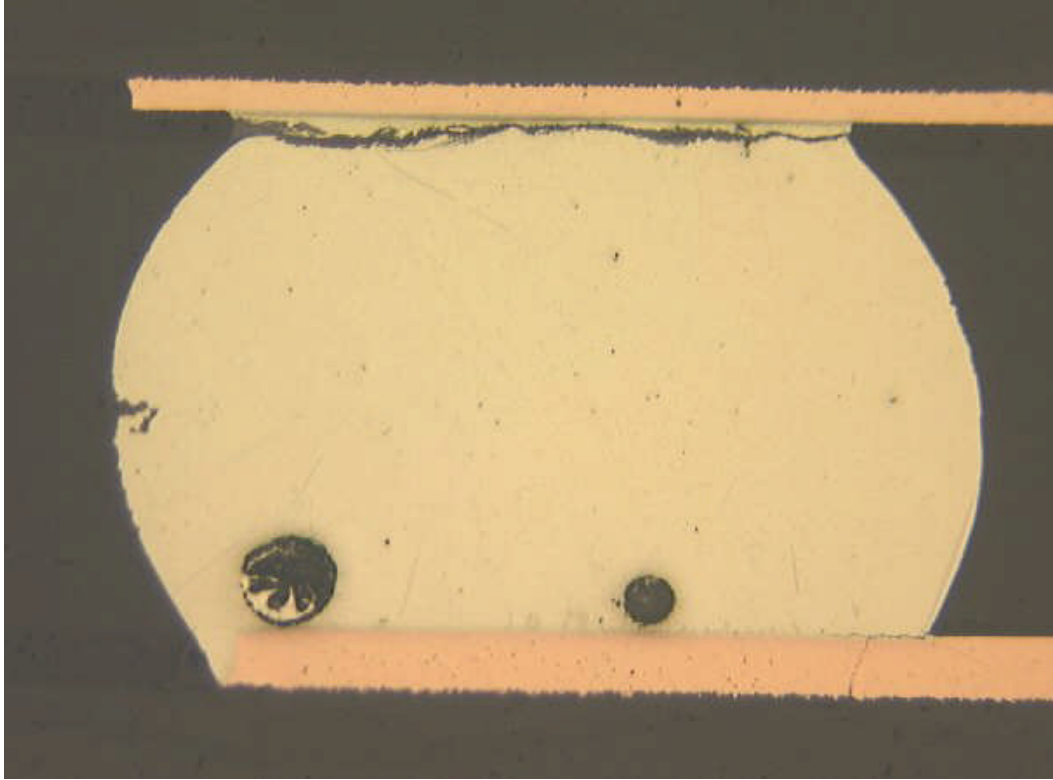
Figure 11. Ball interface fracturing, trace fracturing, and voiding in component BGA U4 from Vibration Board 77.

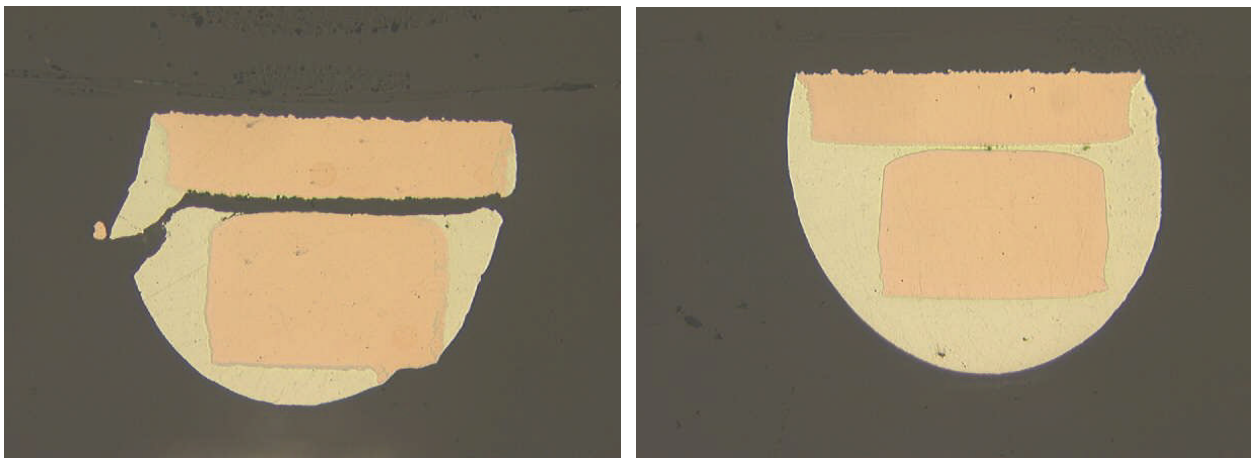
Figure 12. Lead to pad interface fracturing and poor wetting found in component TQFP U3 from Thermal Board 158 (left) compared to good characteristics in component TQFP U57 from the same board (right).
